Manhole Inspection Summary

Manhole # S13QQ1010MH

Location Address: **2629 CYLBURN AVE**

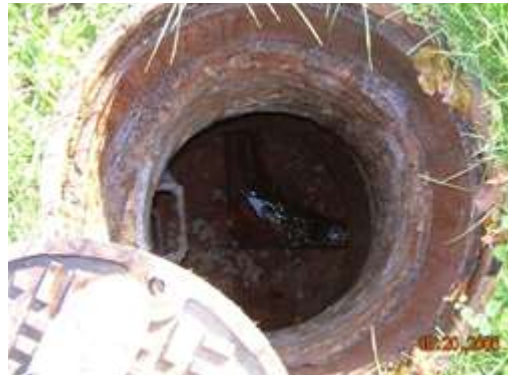
Top View

Frame Offset: **2** (in.)

☒ **Leaks**

Frame leaks. Frame offset. Bench debris.

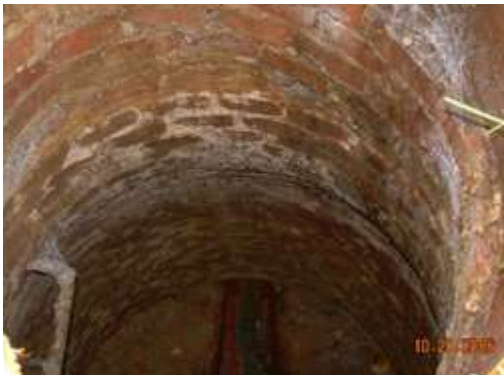
Defect

Condition: ☐ Sound ☐ Cracked ☐ Root Intrusion ☐ Loose Brick ☒ **Deteriorated**

Infiltration: ☐ None ☒ **Joint** ☐ Cracks ☒ **Mortar** ☐ Roots ☐ Wall

Infiltration: ☐ None ☐ Joint ☐ Cracks ☒ **Mortar** ☐ Roots ☒ **Wall**

Adjustment deterioration and infiltration.
Corbel infiltration.

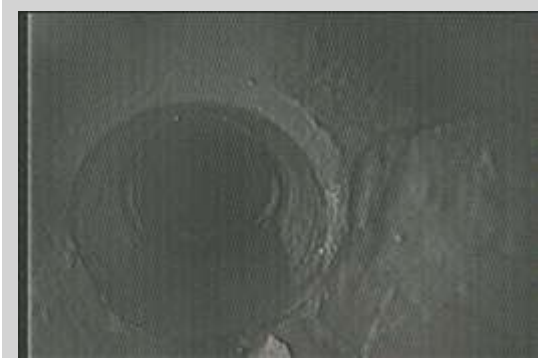
8 in. Circular Gravity Sewer Pipe Out @ 12 O'Clock

Infiltration: **Evidence** Pipe Seal Cond: **Cracked**

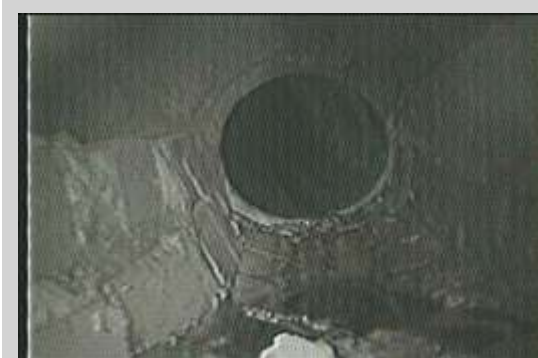
6 in. Circular Gravity Sewer Pipe In @ 3 O'Clock

Channel deterioration.
